## Intensities distribution and parameters controlling their geographic differentiation during the earthquakes of Izmit and Düzce (Turkey 1999)

E. L. Lekkas

*Abstract.* On 17th August and 12th November 1999 the wider area of Yalova, Gölcük, Izmit, Adapazari, Düzce, Kaynasli and Bolu, to the south-southeast of Istanbul (Turkey) was hit by two seismic shocks with magnitude  $MW = 7.4$  and  $MW = 7.1$ , respectively. The two events are attributed to reactivation of two adjacent segments of the North Anatolian Fault Zone, a major E-W right-lateral strike-slip fault zone that runs across Turkey. The earthquakes produced surface ruptures over a distance of at least 150 km, as well as settlement, soil fissures, liquefaction, landslides, tsunamis and subsidence. In both cases, the damage distributed was mainly along an E-W aligned zone more than 180 km long and a few km wide. Damage and intensity evaluation followed the  $EMS_{1992}$  and the updated  $EMS_{1998}$  scales. The maximum intensities approached XII in both earthquakes. Intensity maps show alignment parallel to the strike of the seismic faults, with local variations due to geometry and kinematics of certain tectonic structur

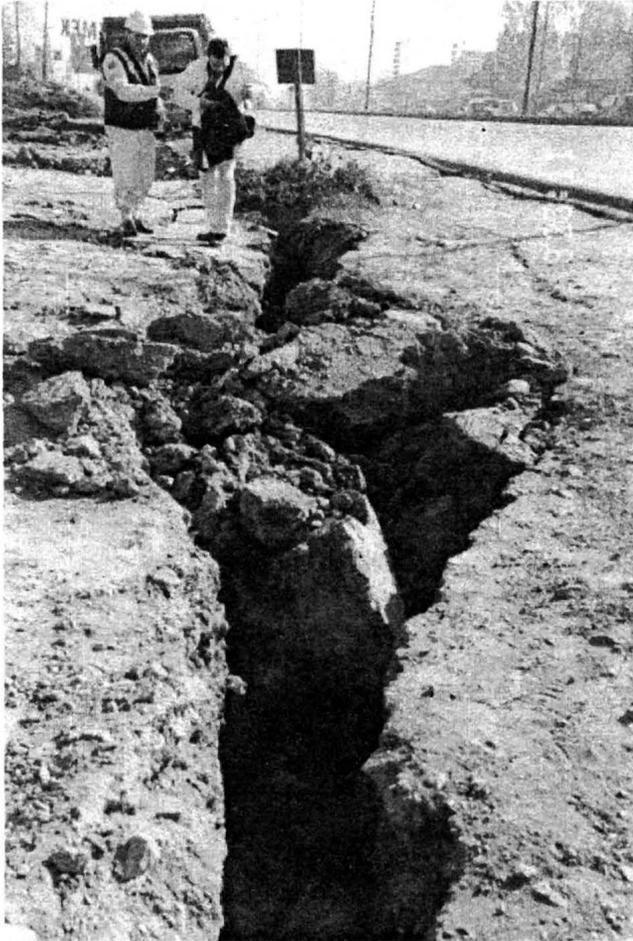
Fig. 2. Surficial occurrence of the portions of the North Anatolian Fault Zone that ruptured during the 12th November 1999 earthquake in Kaynasli

Field observations show that the surficial rupture was more than 90 km long (Lekkas et al., 1999), vertical with right-lateral displacement in excess of 3 meters, in good agreement with the instrumental data (Fig. 1, 2). This seismic fault extended into the submarine area of Marmara bay, west of Gölcük.

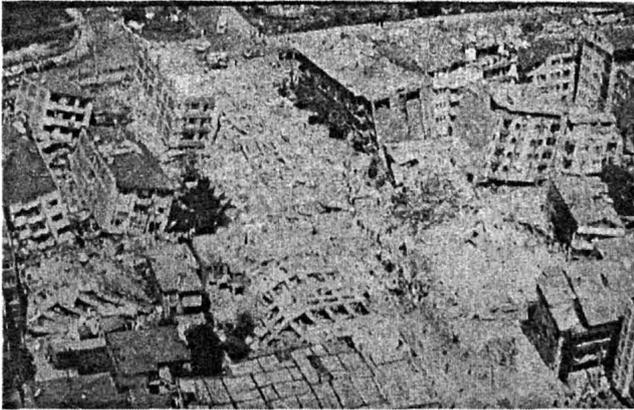
Fig. 4. Representative view of a portion of Adapazari that suffered total damage (IEMS-98 = XII) after the 17th August earthquake

- The maximum intensities exceeded  $I_{EMS98}=XI$  and locally reached XII (Fig. 4) for both seismic of 17th August and 12th November 1999. During the first earthquake, maximum intensities occurred in the coastal area of Gölcük, in Degirmendere, in Yalova and in Adapazari (Figs. 5, 6). Particularly, total collapse of the constructions occurred in the coastal area of Gölcük, due to the submergence of the region into the Marmara sea. Constructions were not only affected by seismic loading but also

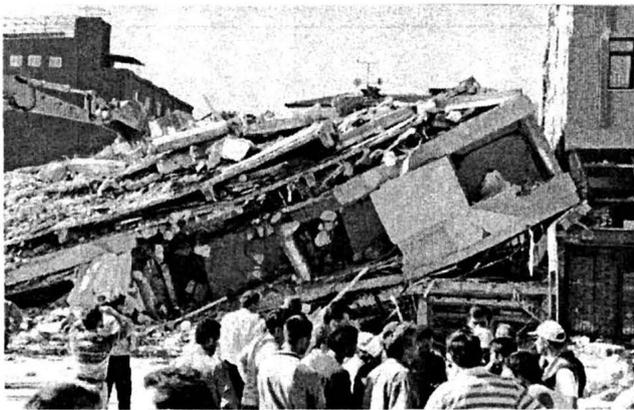
Fig. 5. Reinforced concrete frame structure that collapsed in Gölcük town (damage degree 5)

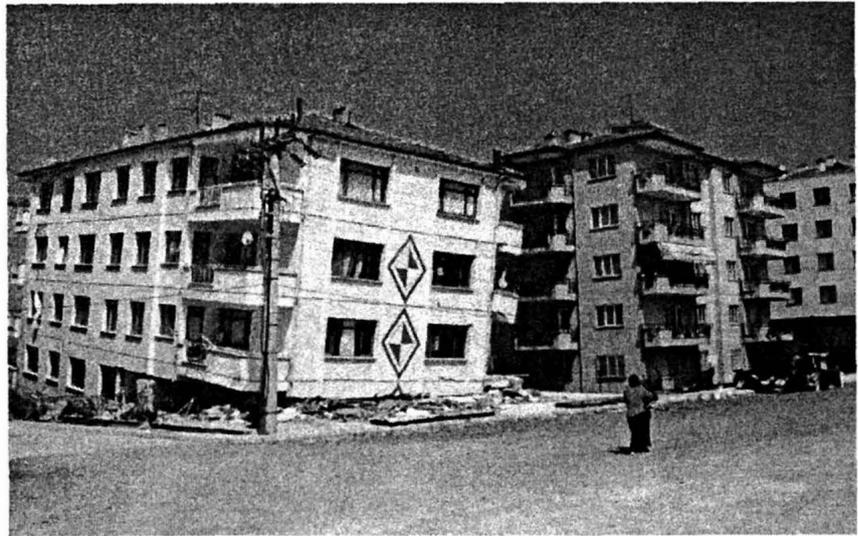
Fig. 6. Reinforced concrete frame structure that sustained collapse of ground floor in the area of Gölcük -Degirmendere (damage degree 5)

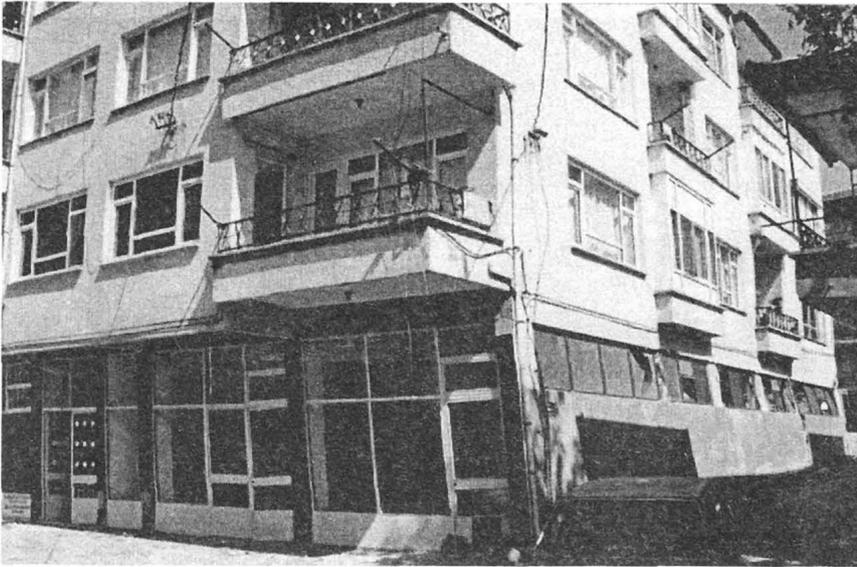
Fig. 7. Reinforced concrete frame structure in Yalova that displayed first storey column-hinge deformation, but did not collapse (damage degree 4)

began at Yalova, was found again at Gölcük, passed through Izmit and stopped in Sapanca lake. The zone reappeared in Adapazari and terminated east of the town (Figs. 7, 8, 9). The width of the zone ranged from 100 m to 200 m. After the 12th November 1999 earthquake,  $I_{EMS-98} = X$  contours were arranged in a similar E-W trending zone, which covered the areas of Hendek, Düzce, Kaynasli and is up to 800 m wide at places. The exact estimation of the intensities that were attributed to the second earthquake was quite hard to make (12th November 1999) in the area between Adapazari-Düzce, because constructions had already been damaged by the earthquake of 17th August 1999. In this case, the cumulative effect of both earthquakes was estimated, incorporating the damage from both earthquakes. In Düzce, about 30% of the damage is attributed to the first earthquake and 70% to the second earthquake. This estimate regards only the structural elements of reinforced concrete constructions. It was found that the first earthquake exhibited maximum intensities that reached  $I_{EMS98} = VIII$  in an E-W zone at Düzce area, while after the second earthquake intensities exceeded  $I_{EMS98} = X$  and locally approached XI. This may be attributed to the fact that the resistance of the constructions had already been weakened by the first earthquake.

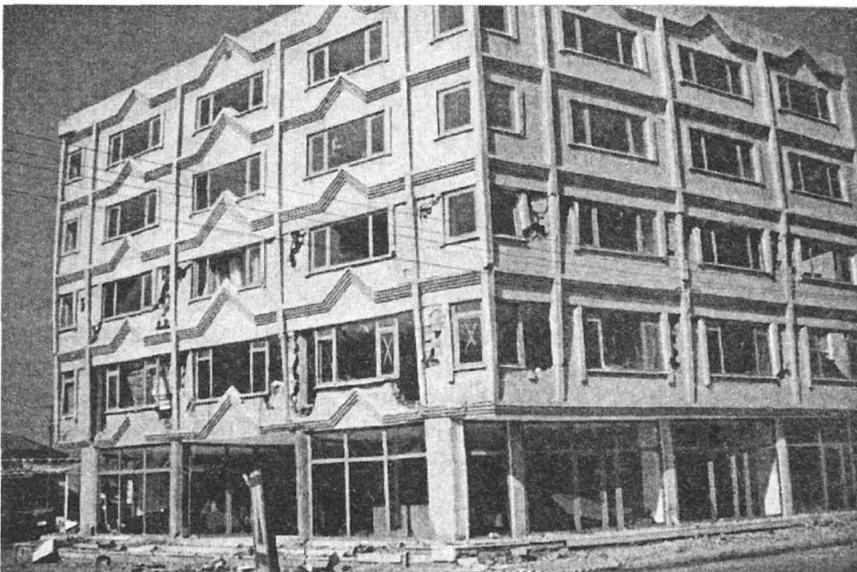
Fig. 8. Reinforced concrete frame structure with light structural damage but heavy damage in the infill brick walls at Gölcük (damage degree 3)
